Manhole Inspection Summary

Manhole # S37QQ_029MH

Insp Date: **1/16/07 8:08 AM**

Location Address: **426 26TH ST**

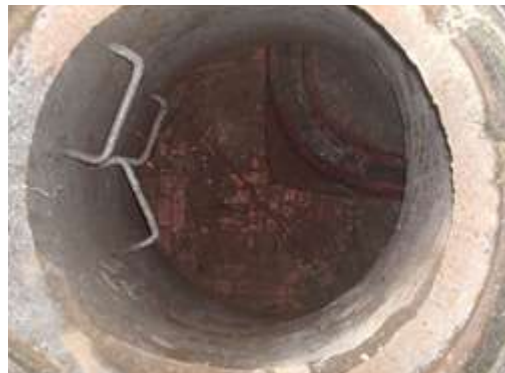
Top View

Evidence of surcharge - Bench debris.

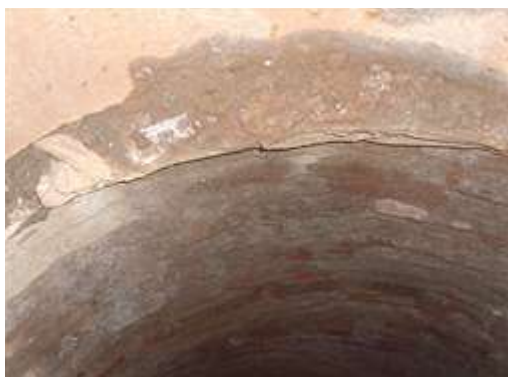
Defect

Frame Offset: **2** (in.) Condition: ☐ Sound ☐ Cracked ☒ **Leaks**

Condition: ☐ Sound ☐ Cracked ☐ Root Intrusion ☐ Loose Brick ☒ **Deteriorated**

Infiltration: ☐ None ☒ **Joint** ☐ Cracks ☐ Mortar ☐ Roots ☒ **Wall**

Frame leaks. Adjustment deterioration and infiltration.

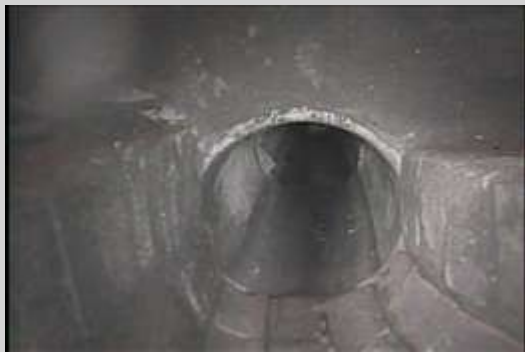
8 in. Circular Gravity Sewer Pipe Out @ 12 O'Clock

Pipe Material: **Clay** ☐ Pipe Lined

Invert Depth: **7.18** (ft.) Flow Characteristics: **Slow**

Infiltration: **None** Pipe Seal Cond: **Unknown**

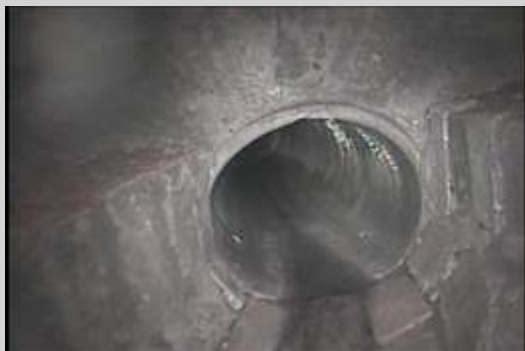
8 in. Circular Gravity Sewer Pipe In @ 3 O'Clock

Pipe Material: **Clay** ☐ Pipe Lined

Invert Depth: **7.10** (ft.) Flow Characteristics: **Slow**

Infiltration: **None** Pipe Seal Cond: **Unknown**
